# Crystal Fire® Plus: Complete Troubleshooting Guide

For Crystal Fire® Plus burners that are exhibiting nuisance shutdowns, please follow this troubleshooting guide. A nuisance shutdown can be defined as any shutdown that is not initiated by the user. This can occur immediately upon startup or after approximately 20-30 minutes.

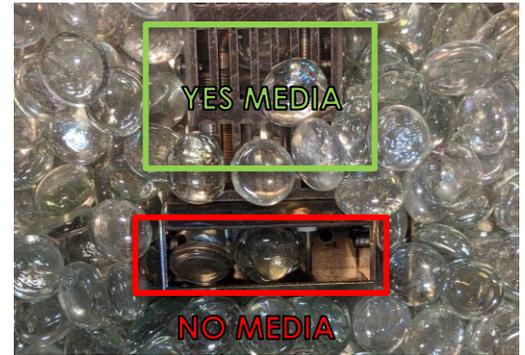
Image 1

1. When lighting the burner, ensure that the control knob is being fully depressed until it cannot move further. Partial engagement of the internal components due to a partially depressed knob can cause nuisance shutdowns.
2. Ensure that there is no media within the wind guard. See Image 1. If there is media present inside the wind guard, carefully remove it from the wind guard opening. Media can be present on the back cover of the wind guard.
3. Verify that wind guard is properly positioned on burner surface. Wind guard assembly should be parallel to wind fins on linear burners. See Image 2.
4. Check the entire length of the thermocouple for severe kinks or breakage. See Image 3. If damage has occurred to the thermocouple, a replacement assembly must be sent out. (P/N: VCSV-WG)

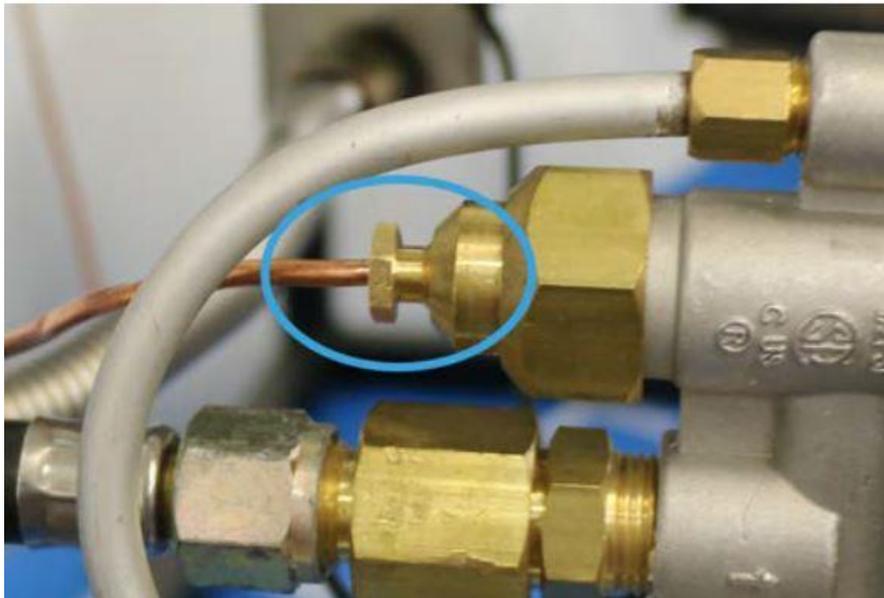
Image 5

5. Ensure that the thermocouple is properly tightened. A properly tightened thermocouple will have one thread exposed from the body of the control valve. See Image 4.
6. Verify that thermocouple is not contacting the wind guard in any location. The tip of the thermocouple should be centered in the hole of the wind guard. See Image 5.

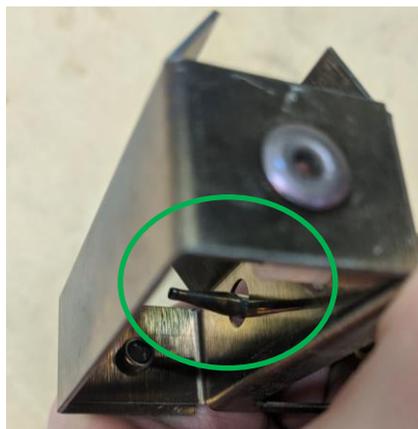
Image 6

7. Ensure burner is operating on the correct fuel type. Burners are set up standard for LP gas operation. Conversion to natural gas operation requires both the valve and burner orifice to change as well as closing the air shutter. See Image 6.

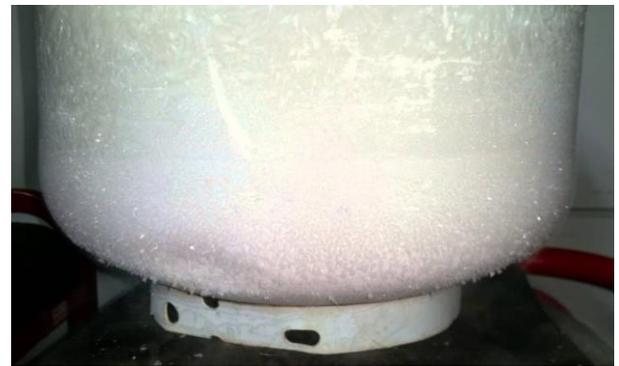
Image 7

8. If Steps 1-7 have been completed and burner still shuts down after 20-30 minutes, check the outer surface of the LP tank after the burner shuts down. If there is significant frost on the tank, safety devices inside the regulator have likely activated and caused the shutdown. See Image 7. This issue would be especially applicable to CFP1242 and CFP30 burners, which are larger burners.

This can be verified by listening to the control valve. If the flame goes out and is followed by an audible click at the valve, this means that the LP tank caused the shutdown. If the flame goes out at the exact same time as the click at the valve, the system is still not receiving an adequate signal from the thermocouple. Follow the link or QR code below for a video demonstrating the "click".
