# Crystal Fire® Plus: Complete Troubleshooting Guide

For Crystal Fire® Plus burners that are exhibiting nuisance shutdowns, please follow this troubleshooting guide. A nuisance shutdown can be defined as any shutdown that is not initiated by the user. This can occur immediately upon startup or after approximately 20-30 minutes.

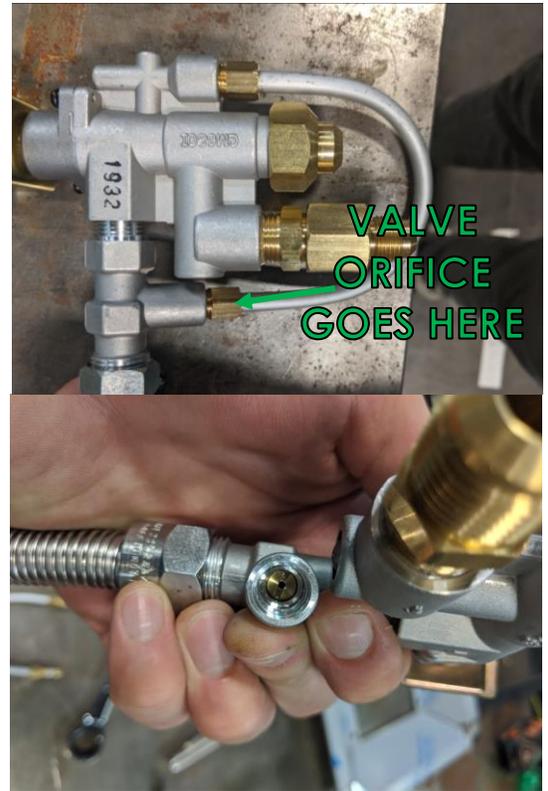
Image 6

7. Ensure burner is operating on the correct fuel type. Burners are set up standard for LP gas operation. Conversion to natural gas operation requires both the valve and burner orifice to change as well as closing the air shutter. See Image 6.
